Safety Alert

Issue No. 1
Date: Jan 2019

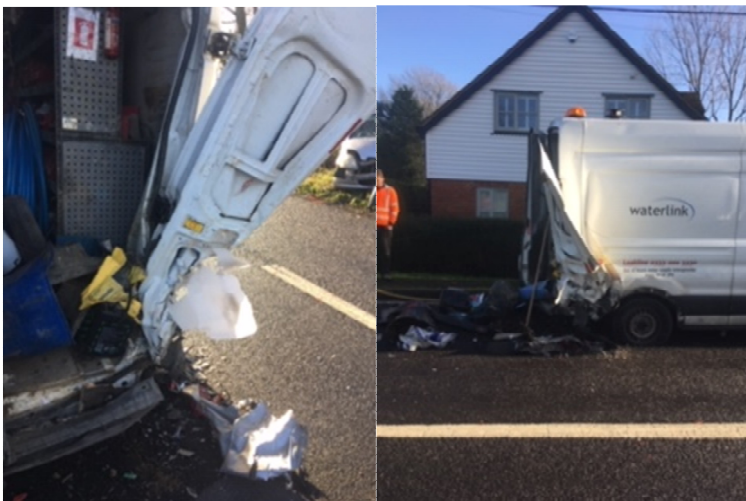
One of the team had just retrieved an item from the back of the van and was handing it to his colleague when he heard a bang as a third party vehicle drove into the back of their van.

The other driver reported being dazzled by the low sun. Had this occurred moments before, the Waterlink technician would have been in the collision path.

The gang had installed a taper zone suitable for a 30mph road, the marked speed of the road, however the prevailing speed of the vehicles was faster as it was a long straight road on the exit from the village.

After the incident the taper zone was extended in order to ensure that if a driver failed to see the van they would hit cones rather than the van or, worse still, one of the technicians.

- When parking try to park off of the carriageway.
- Where this is not possible consider how visible you may be taking account topography and weather.
- Risk assess the signage that you will need and if necessary install a provision for a faster road in order to minimize risk
- Wherever possible place items that you will need so that they can be accessed by the side door.
