Major MOP RTC

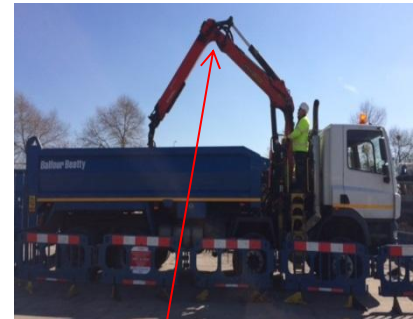
The team had completed the task at one location and were in the process of moving onto the next but they failed to stow the Grabs crane arm into its safe travelling position.

The arm, still in a raised position, as the vehicle moved forward, caught an overhead telephone cable. However, the cable did not break, and instead, the wooden telegraph pole carrying the cable, snapped, leaving a stub of between 2'-3' and swinging the post out into the live carriageway into the path of an oncoming vehicle.

Mock Up of likely position of boom at time of incident

- Always ensure you check that the arm of the crane is stowed in its safe travelling position before moving the vehicle / grab.
- Never move the vehicle / grab unless the arm of the crane is stowed in its safe travelling position.
- Always check the safety features of the vehicle / grab are all in good working order before you leave the depot and again periodically throughout the day.
- Report any defects with equipment or safety features immediately and quarantine from use until matters are resolved
- If anything changes thought the day STOP and seek advice from your supervisor and/or line manager.

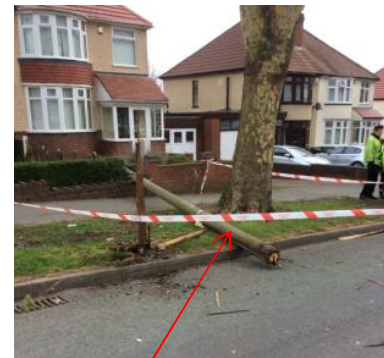
Broken BT wooden Pole

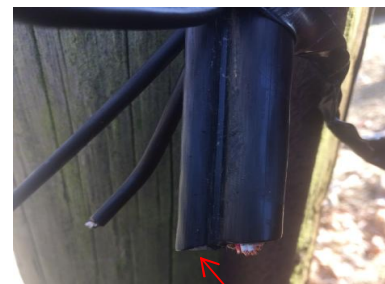
BT Main cable with steel section
