<b>AffinityWater</b>	<h1 style="text-align: center; color: white;">Health &amp; Safety First Alert</h1>				<div style="display: flex; align-items: center;"> <div style="border: 1px solid red; width: 20px; height: 10px; margin-right: 5px; margin-bottom: 5px;"></div> <span style="color: red;">HIGH RISK</span> </div> <div style="display: flex; align-items: center;"> <div style="border: 1px solid orange; width: 20px; height: 10px; margin-right: 5px; margin-bottom: 5px;"></div> <span style="color: orange;">MEDIUM RISK</span> </div> <div style="display: flex; align-items: center;"> <div style="border: 1px solid green; width: 20px; height: 10px; margin-right: 5px; margin-bottom: 5px;"></div> <span style="color: green;">LOW RISK</span> </div>	
<b>Classification:</b>	Fatality		RIDDOR Specified Injury		RIDDOR >7-day injury	
	Lost Time Injury (<7day)		RIDDOR Dangerous Occurrence		High Potential Event	X

Road Traffic Collision		Service Strike			
<b>Incident Date / Time:</b>	4 <sup>th</sup> December 2024, 10:00

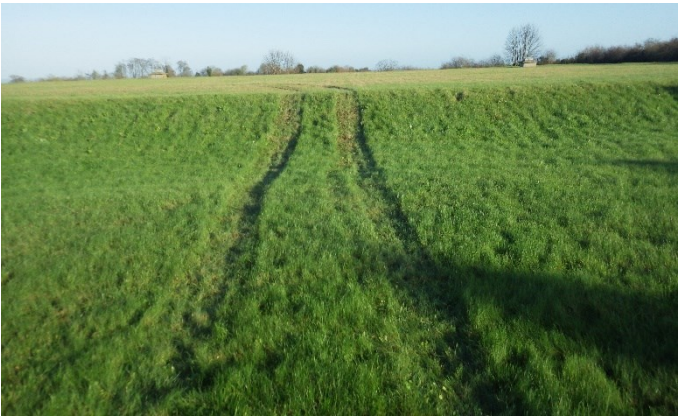
<b>Location:</b>	Weston Hills Reservoir					
<b>Business Area:</b>	Treatment					
<b>Occupation:</b>	N/A					
<b>Details of Injury / Damage:</b>	No injuries. Potential damage to reservoir.					
<b>Responsible Manager:</b>	Andrius Zabotka					
<b>Contractor Name:</b>	J Browne					
<b>EcoOnline ID:</b>	71104					
<b>Brief Description:</b>	<p>The Team Leader was using a 3t excavator to pull pipework into the open trench between the two shafts on site. In doing so the 3t excavator got stuck and could not get back out of the area they were working within due to the sloped banks.</p> <p>The team leader then utilised the onsite 5t excavator to assist with pulling the 3t excavator free. In doing so the team have tracked both machines across the top of the reservoir and the sloped banks.</p> <p>This had the potential to damage the reservoir roof as it is not designed to have vehicles driving on top of the roof.</p>

<b>Immediate Actions Taken:</b>	<ul style="list-style-type: none"> <li>Reservoir Inspecting Engineer informed.</li> <li>Restricted area identified to the site team.</li> </ul>					
<b>Next Steps:</b>	<ul style="list-style-type: none"> <li>Full investigation to be completed.</li> <li>Internal inspection of the reservoir to identify any signs of a structural damage.</li> <li>Local Incident Review to be held.</li> <li>Learning to be shared to all Affinity Water and partners</li> </ul>
