AffinityWater	<h1 style="margin: 0;">Health & Safety</h1> <h2 style="margin: 0;">First Alert</h2>				<div style="display: flex; flex-direction: column; align-items: flex-start;"> <div style="display: flex; align-items: center; margin-bottom: 5px;"> <input checked="" type="checkbox"/> HIGH RISK </div> <div style="display: flex; align-items: center; margin-bottom: 5px;"> <input type="checkbox"/> MEDIUM RISK </div> <div style="display: flex; align-items: center;"> <input type="checkbox"/> LOW RISK </div> </div>	
Classification:	Fatality		RIDDOR Specified Injury		RIDDOR >7-day injury	
	Lost Time Injury (<7day)		RIDDOR Dangerous Occurrence		High Potential Event	X
	Road Traffic Collision		Service Strike		Non-lost time injury	X
Incident Date / Time:	15 th January 2025, 14:05

Location:	Booster Station, Horsley Cross WTW					
Business Area:	Treatment					
Occupation:	Contractor Electrician					
Details of Injury / Damage:	IP - Burns to right arm/hand, left eye sustained some damage from flash, beard and eyelashes also burned Damage to inside of new MCC panel and cables

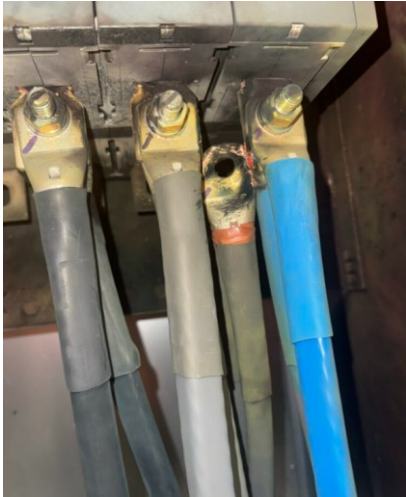
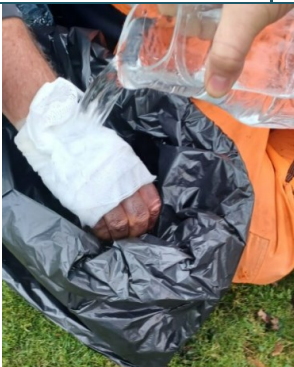
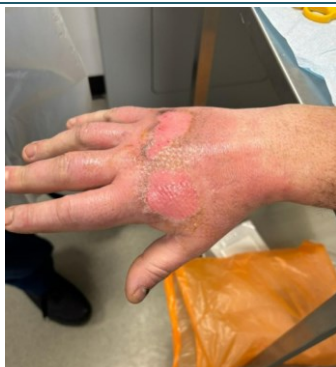
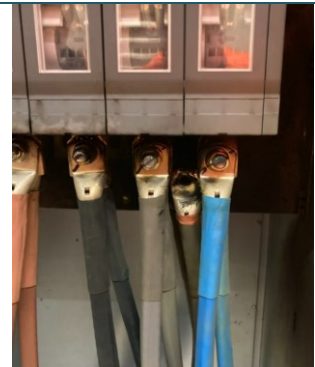
Responsible Manager:	Neil Walkington-Mayo					
Contractor Name:	Max Wright					
EcoOnline ID:	72602					
Brief Description:	Contractor was working to install cables into a new change-over panel. The cables in the panel were being aligned with the rear terminals on the bottom of the change-over switch, when the lug on the loose cable shorted between the L3 terminal and Neutral terminal on the front row of terminals. This caused a full short and arc flash causing burns to the right-hand and face of the MWL Tech. Power to the site was immediately lost but then restored through the Main Incomer. The IP was found lying on the floor by his colleague, who helped him outside after ensuring he was safe to move.					
Immediate Actions Taken:	Once outside, the IP was helped by the on site AW team who gave first aid and took the IP to hospital (instead of waiting 2 hours for an ambulance). Production team then ensured the site was made safe and isolated to prevent access. They then had to carry out work to ensure there was a standby supply should the site go off again causing supply interruption.

Next Steps:	<ul style="list-style-type: none"> Full investigation to be completed. Local Incident Review to be held. Learning to be shared to all Affinity Water and partners.
