<h1 style="text-align: center; color: white;">Health &amp; Safety First Alert</h1>				<input checked="" type="checkbox"/> <b>HIGH RISK</b> <input type="checkbox"/> <b>MEDIUM RISK</b> <input type="checkbox"/> <b>LOW RISK</b>
	<b>Classification:</b>	Fatality  Lost Time Injury (<7day)  Road Traffic Collision	RIDDOR Specified Injury  RIDDOR Dangerous Occurrence  Service Strike	RIDDOR >7-day injury  High Potential Event  Damage	  X  X
<b>Incident Date / Time:</b>	17 <sup>th</sup> December 2024, 12:30		 		
<b>Location:</b>	Gloucester Road, Bagshot, Surrey				
<b>Business Area:</b>	South Community Operations Delivery - McFadden				
<b>Occupation:</b>	Reinstatement Team				
<b>Details of Injury / Damage:</b>	Fire damage to customer property				
<b>Responsible Manager:</b>	Nic Bailey				
<b>Contractor Name:</b>	McFadden				
<b>EcoOnline ID:</b>	71621				
<b>Brief Description:</b>	Team were onsite to carry out the finished layer of tarmac. They had laid the tarmac and started to overband the edges. The excavation was right next to a row of conifer trees, and whilst they were burning the overbanding a branch caught light. The team put it out but quickly realised the bushes were on fire from t

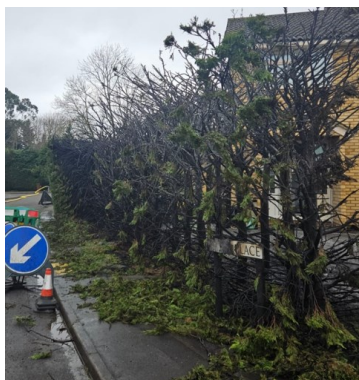
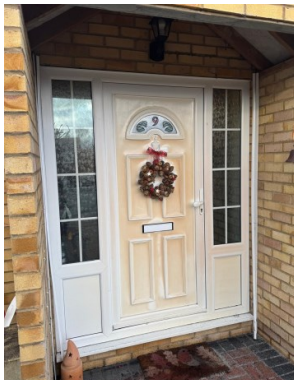
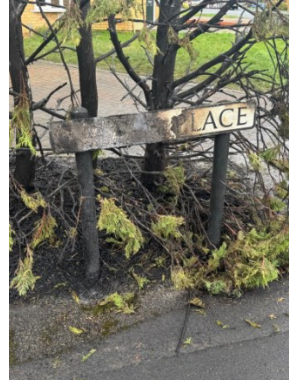
<b>Immediate Actions Taken:</b>	The team leader called the fire brigade who were on site with in 5 minutes.  They put out the fire and assessed the damage. The fire had burnt the trees to the ground; the bin and drainage downpipe had been melted and also the wooden gate and fence were burnt. The fire also cracked two windows and caused staining and warping to other parts of the house.				
<b>Next Steps:</b>	<ul style="list-style-type: none"> <li>• Full investigation to be completed.</li> <li>• Local Incident Review to be held.</li> <li>• Learning to be shared to all Affinity Water and partners.</li> </ul>
