Conquip Boat Skip (CA122-03000) Recall

Safety Alert

Conquip Boat Skip (CA122-03000)

Date: 16/01/2019

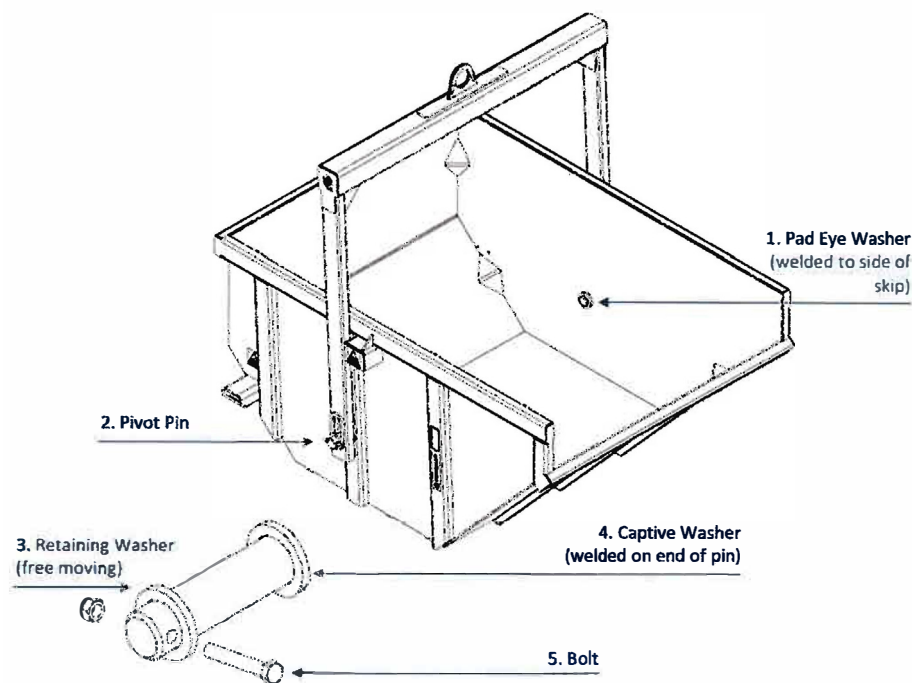
Diagram showing correct free movement of retaining washer

Conquip Engineering Group are issuing a Safety Alert for the CA122-03000 Boat Skip. An issue with 2015 models has been identified which could potentially cause the weld around the captive washer on the end of the pivot pin to fail.

If the retaining washer (Item 3) on the end of the pivot pin (Item 2) is welded to the inside of the skip, therefore disabling free movement of the pin, these items should be quarantined.

They should be returned to Conquip Engineering Group for remedial work or quarantined on site until one of our field service engineers can visit to carry out the necessary repairs.

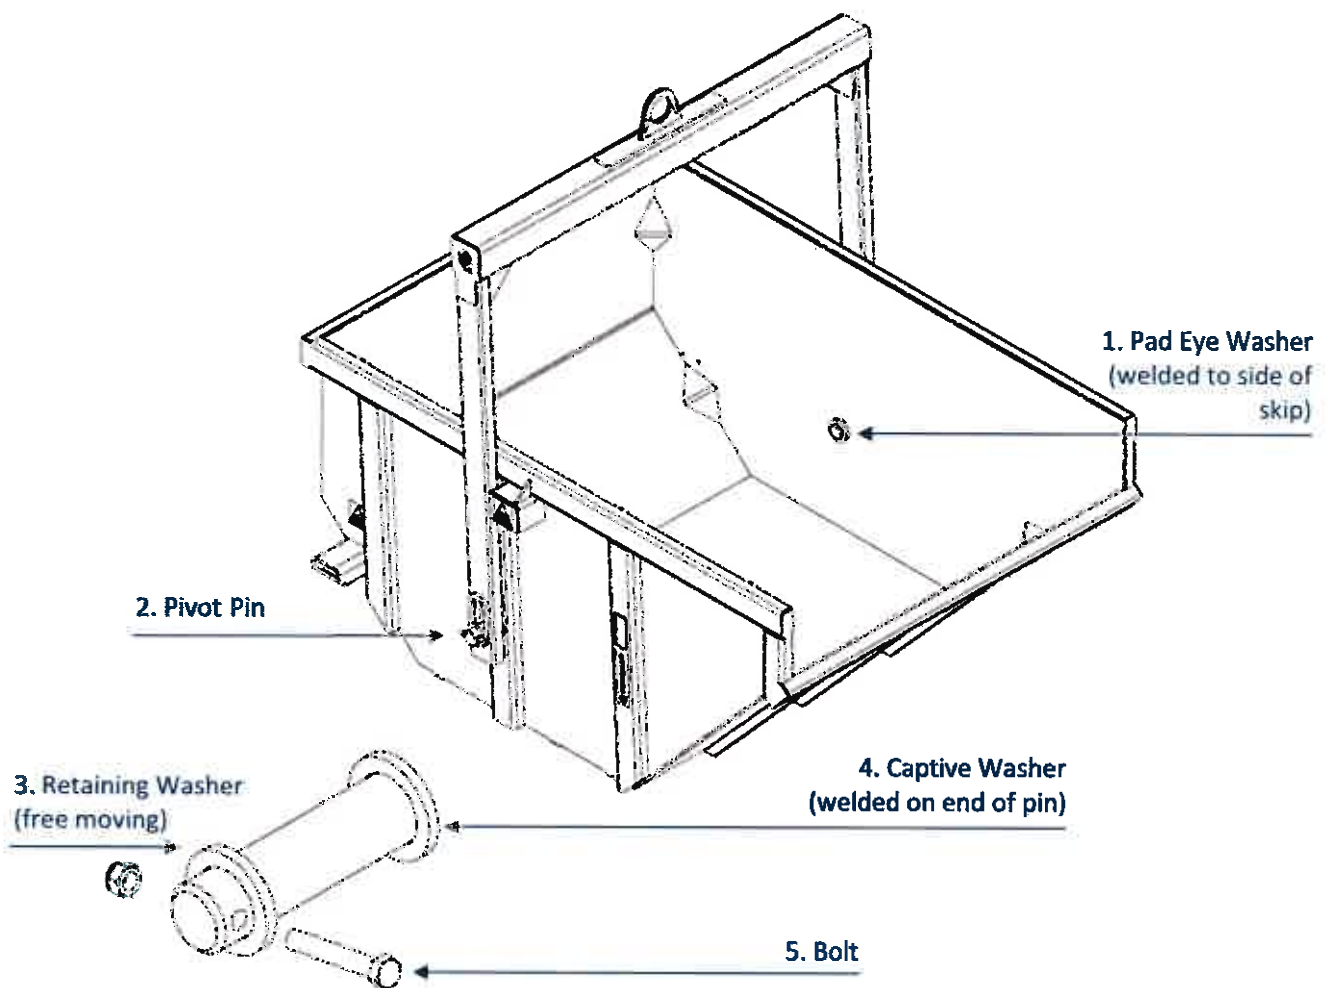
FIG 1

Conquip Engineering Group are issuing a Safety Alert for the CA122-03000 Boat Skip. An issue with 2015 models has been identified which could potentially cause the weld around the captive washer on the end of the pivot pin to fail.

The correct assembly should show the captive washer (Item 4, FIG 1) welded to the end of the pivot pin (Item 2, FIG 1) allowing free movement of the pin against the pad eye washer (Item 1, FIG 1) that is fully welded to the inside of the skip.

If the retaining washer (Item 3, FIG 1) on the end of the pivot pin (Item 2, FIG 1) is welded to the inside of the skip, therefore disabling free movement of the pin, these items should be quarantined. They should be returned to Conquip Engineering Group for remedial work or quarantined on site until one of our field service engineers can visit to carry out the necessary repairs.

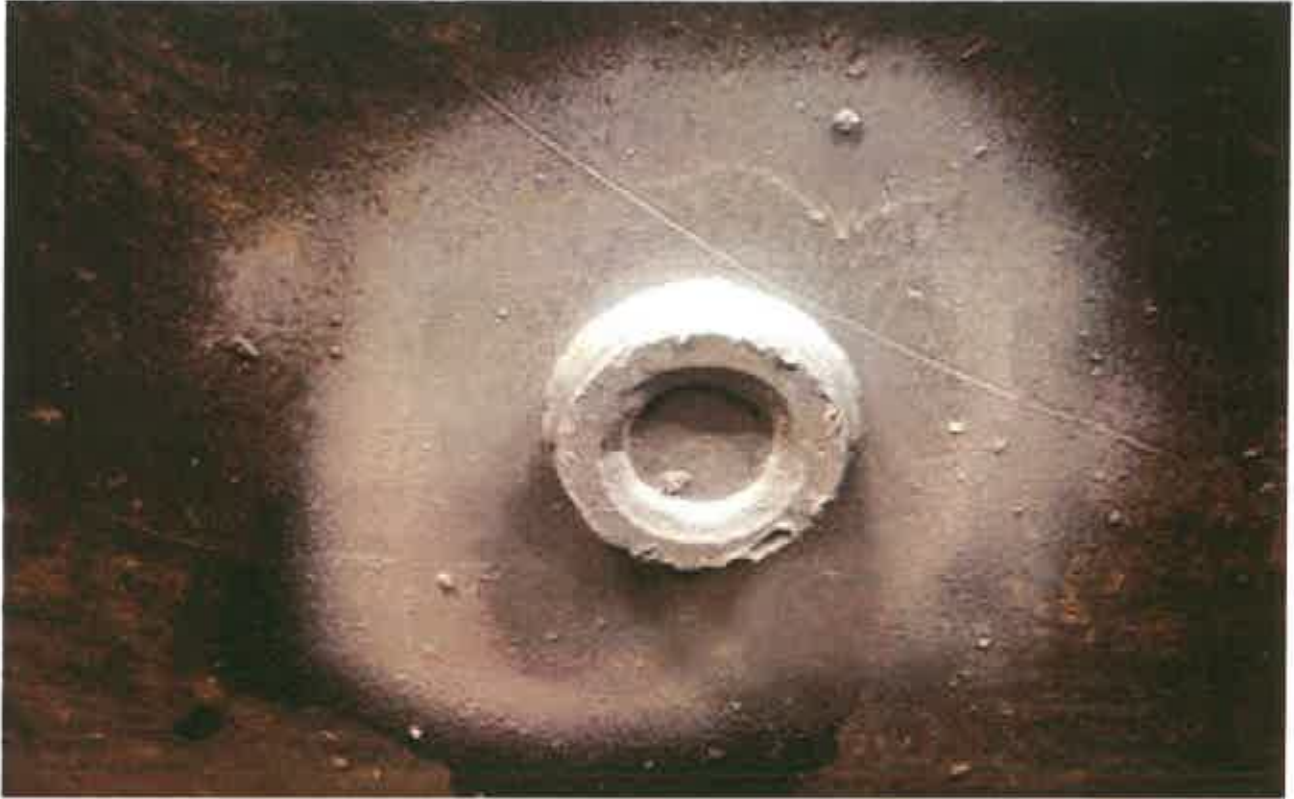
FIG 2

The view below, FIG 2, shows the welded pad eye washer (Item 1, FIG 1) and the captive washer (Item 4, FIG 1) on the inside of the skip body.
