Safety Alert

Reversing Incident M4 SMP

11 November 2019

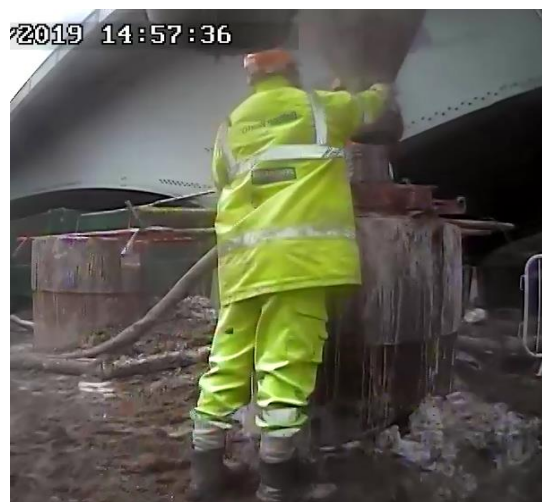
On the 8th October 2019 at the M4 SMP scheme, during a concrete delivery an operative was struck from behind by a reversing concrete vehicle.

The driver entered site, visited the testing area to deposit a concrete sample and then returned to his cab leaving the vehicles concrete chute extended.

The driver then proceeded to the piling area swung right and then began reversing towards the pile location.

During this manoeuvre a concreting operative was standing beside the pile casing with his back to the vehicle and was struck on the rear of his safety helmet by the vehicles chute.

The operative was shook up but not injured.

➤ People, vehicle and plant interface must be planned and controlled through the use of a suitable hierarchy of control:

- 1) **Eliminate** - Where reasonably practicable the need to reverse must be planned out of the work and access gates to work locations installed.
- 2) **Minimise** - When reversing cannot be avoided it should only take place in designated reversing areas, with pedestrians physically segregated and the use of reversing aids.
- 3) **Mitigate** - Where all the above are not possible, reversing must only take place under the control of a competent, Plant Vehicle Marshall.
