SHE Alert

Hungry Snout —RIDDOR Lost Time Injury

SHE 0009

24th May 2019

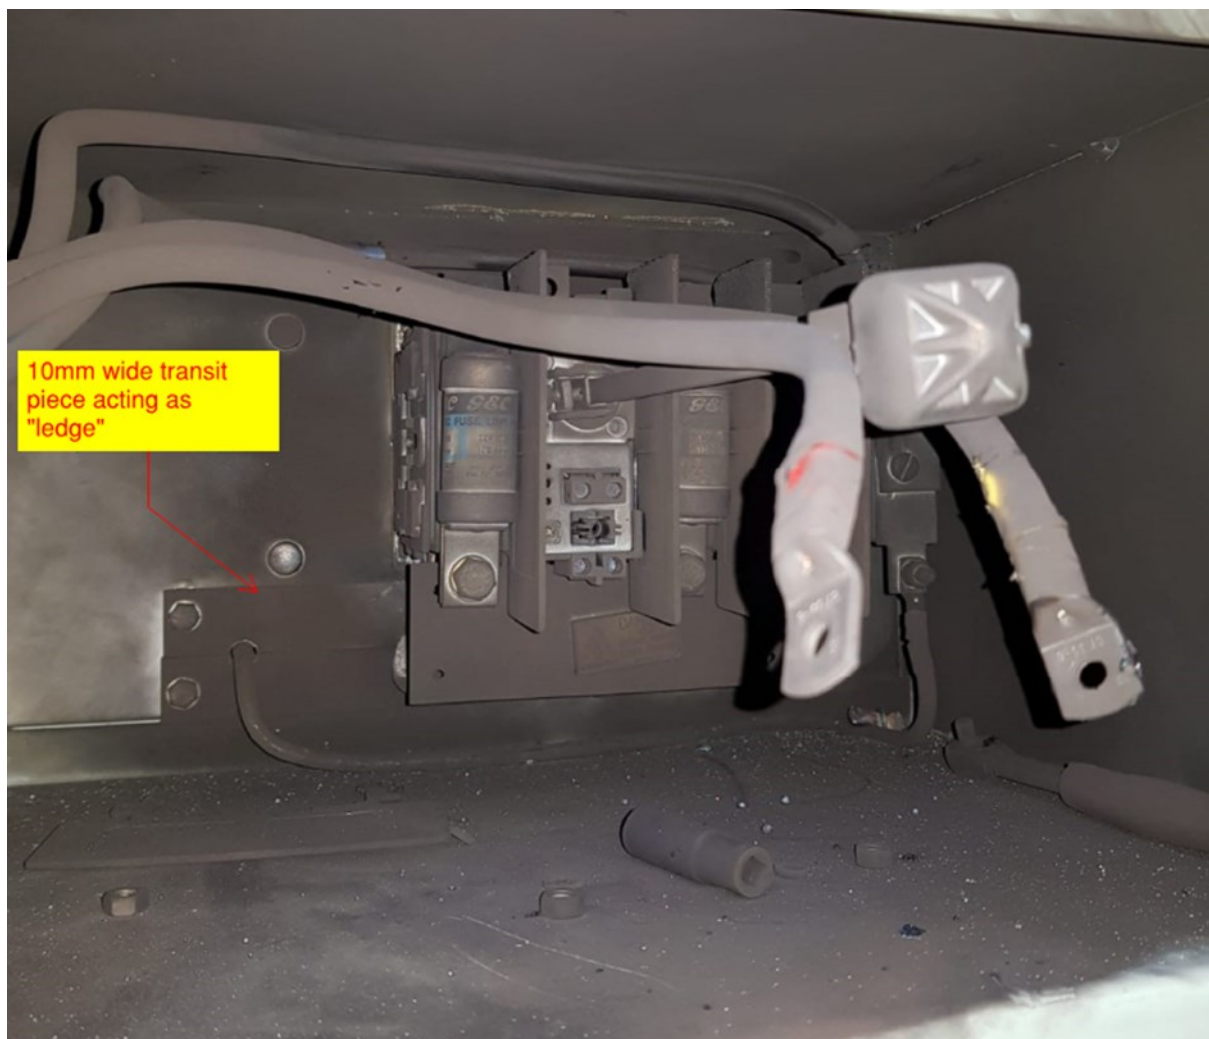
The electrician had been working in the compartment with the fuse switch isolated. Whilst inserting the bolt through the cable ring crimp and the termination lug on the switch, the bolt was dropped behind the switch and made contact between a live conductor and the compartment backplate, resulting in an electrical short to earth.

Figure 1 – Showing the layout of the compartment

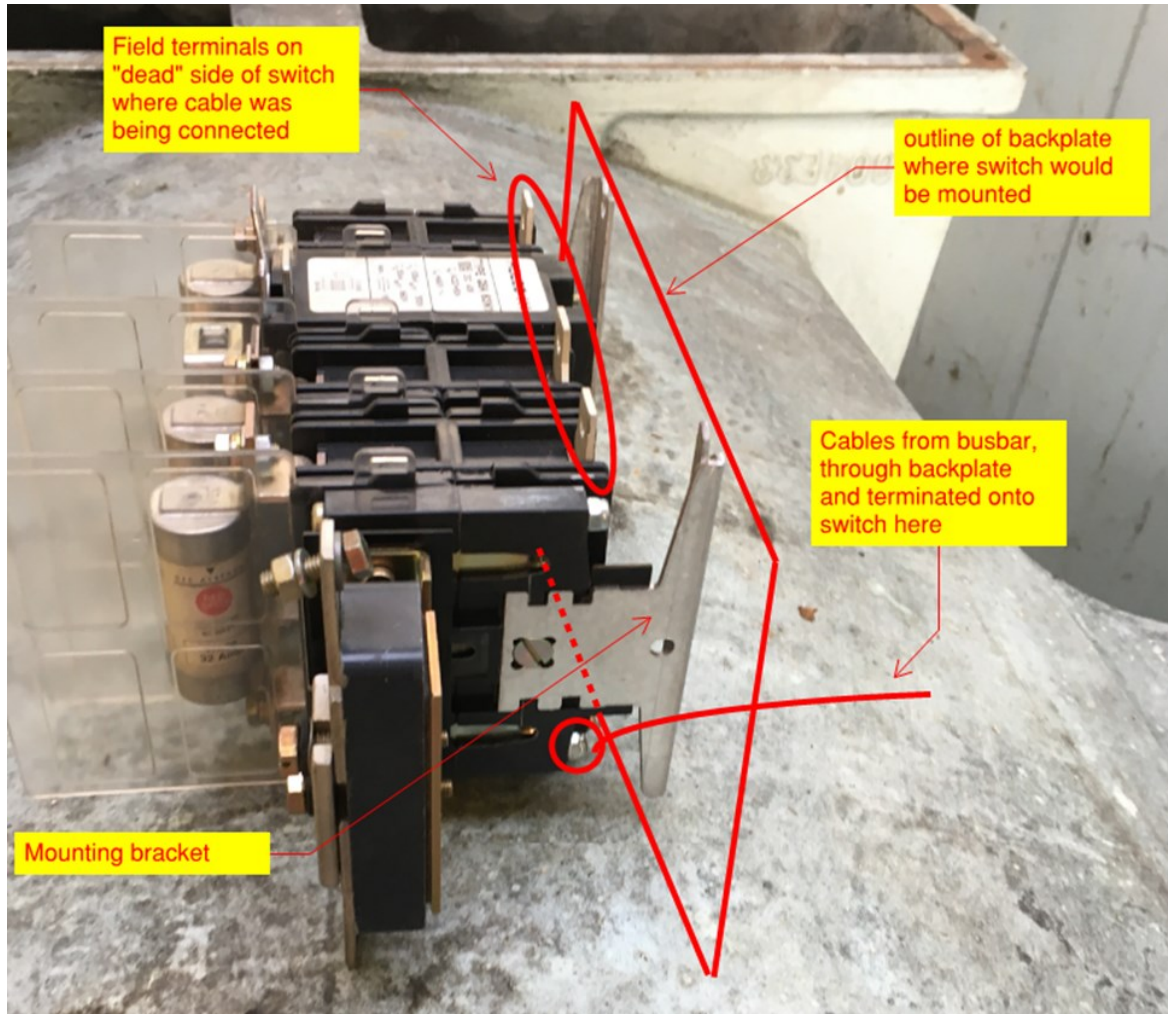
Figure 2 - This is a photo of a replacement switch of the same type marked up to show where the backplate and terminals are.

- The design of the switch includes a gap (20mm to less than 10mm in places) at the back of the switch which was not visible from the front and is still difficult to see from the pictures of the insitu switch;
- The gap is not shrouded to prevent access behind it;
- The fuse switch is cabled from the switchgear busbars. The live cabling from the busbars is connected to the bottom of the fuse switch and the isolated field cabling is connected at the top. This orientation is 180 degrees from current conventional designs; and
- The compartment contains a transit piece to allow the live cable to pass from the busbars to the fuse switch compartment. This transit is proud by approx. 10mm from the bottom of the backplate at the rear of the fuse switch and has assisted in trapping the bolt

The fact that there was a gap and it was unshrouded, coupled with the live terminals on the bottom of the fuse switch and the ledge created by the transit piece, all contributed to the bolt being trapped and the electrical short occurring.

- On current and future projects, where the scope requires interfacing with existing switchgear, a review of the type of switchgear shall be undertaken at the earliest opportunity to determine and mitigate any such hazards
- Any intrusive work on this type of switch shall only be undertaken with the live terminals isolated. This may involve isolation of the relevant MCC
- If it cannot be guaranteed that the live conductors in MCC compartments are adequately protected/shrouded or that the activity can be safely managed, isolation of the MCC must be considered. If this is required, other measures may need to be put in place so it is important the above information is ascertained as soon as possible.
