# SAFETY INFORMATION

## SI 22/03

## HPC BYLOR FALL FROM HEIGHT INCIDENT

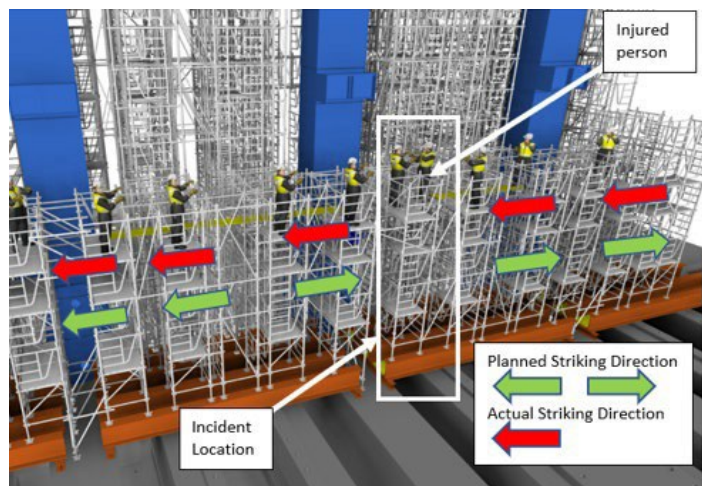
Digital image of the activity before the incident

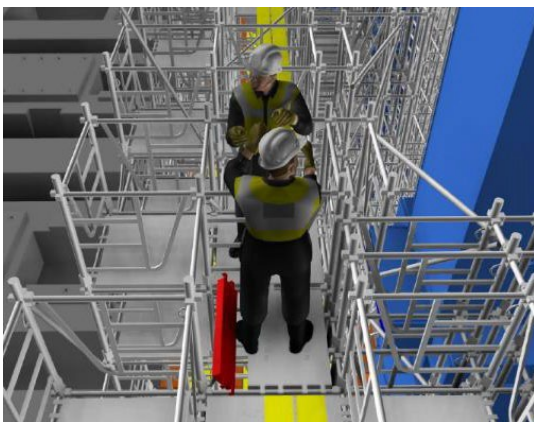
The incident happened when the IP stood, in a location not believed to require clipping on, on a floor pan that was unstable due to incorrect installation. The pan rotated creating a trap door void that the IP fell through.

Image indicating the 'Pan' that rotated

<b>Supplier Information and design quality</b>	<p>Information supplied from the manufacturer did not sufficiently highlight the risks associated with the falsework system and the importance of the anti-tilt device and pan securing pins.</p> <p><b>The falsework supplier has updated their familiarisation training, the system manual and also the SHE risk boxes in their standard design drawings.</b></p>

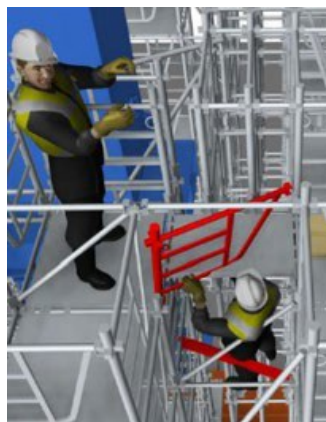
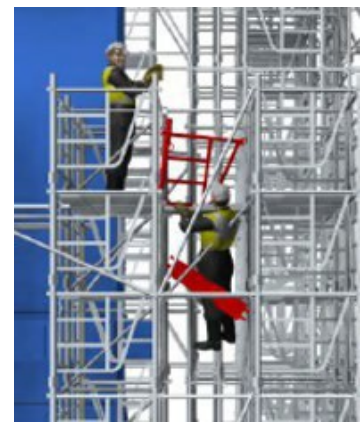
On the 4<sup>th</sup> March 2022 (nightshift), whilst striking falsework under the newly constructed Generator Table [in the Conventional Island Area of Hinkley Point C (Unit 1)] a worker fell 5.2m onto the raft level below. The person involved experienced minor injuries.

Images showing the fall from height

<b>System Training for Falsework and Formwork</b>	<p>Not all construction personnel involved in the erection and dismantling of falsework systems [inc scaffolders] had received familiarisation training in the specific falsework system.</p> <p><b>BYLOR have refreshed training and competence systems and the training centre has increased falsework systems courses. A falsework academy is also being established.</b></p>
<b>Setting People to Work</b>	<p>Visual task sheets communicating the safe system of work were too generic and didn't include sufficient system specific risk information.</p> <p><b>Setting to work procedures have been updated, the quality of visual task sheets and POWRA documents have been improved and supervisor training on effective delivery, confirmation and monitoring has been increased.</b></p>
<b>Effective Reporting and Escalation</b>	<p>Observation reporting processes weren't effective in escalating the earlier issues experienced with the system to the right people/level.</p> <p><b>Everyone has been re-engaged in the importance of escalating H&amp;S issues on site, via any appropriate means but including workforce engagement sessions and via the new insight [app] reporting tool.</b></p>
