Flash Alert

Overturning of 8t Excavator

Stoke Bardolph - Incident

Scheme: Stoke Bardolph, AAD

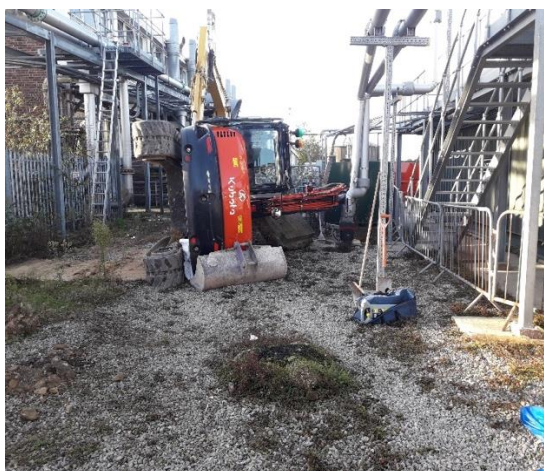
An 8t excavator overturned during the removing and repositioning of a concrete slab from the ground in the CHP area of site.

Photo 1: View from east side of work area

- Ensure weights of excavated materials are considered in relation to excavator capability
- Ensure the stability of materials in excavator buckets has been assessed
- Ensure all personnel are positioned outside of the excavator working zones – 'red zones'

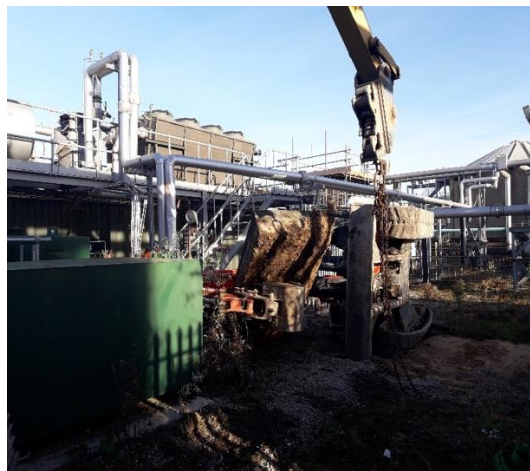
Photo 2: View from west side of work area
