UPVC Joint Failure During Site Pressure Test

Date: 27/11/2020

Scheme: Alcester STW

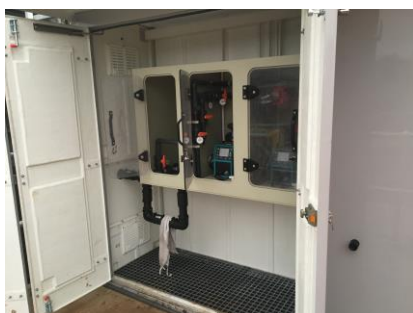
Dosing kiosk

A factory assembled dosing kiosk had been installed and connected to the ferric tank. The task at the time of incident consisted of pressure testing the chemical dosing pumping cabinet pipework to the ferric tank.

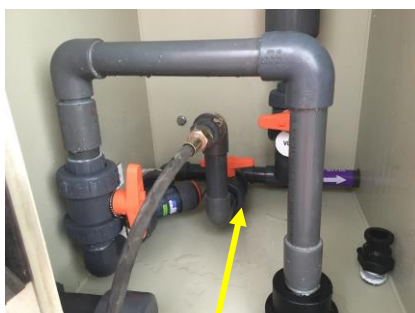
A UPVC joint failed and the drain valve consequently ejected from the cabinet narrowly missing the operator carrying out the pressure test. No one was harmed by the incident.

The site pressure test for the pipework required increase and holding to 6 Bar however, failure occurred on increase at 3 Bar. Pipework had been recorded as tested to 6 Bar in the factory acceptance test document.

Point of Failure

- Review the RAMS and include measures to prevent/reduce operator presence in the danger zone
- Ensure task specific PPE is detailed for pressure testing
- Further investigation into the factory assembly, testing and quality assurance procedures

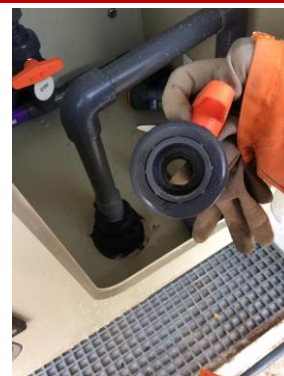
1st inspection of joint indicates lack of glue
