# Flash Alert

## Serious Near Miss Pickup mechanical failure

Incident details		
<b>Contract number:</b> NW24J010	<b>Project name:</b> Valley Gardens	<b>Date:</b> 14/04/2025
<b>Relevant OSSs/OESs/campaigns:</b> <ul style="list-style-type: none"> <li><a href="#">OSS 102: Lifting operations using cranes and excavators</a></li> <li><a href="#">OSS 106: Safe use of plant and equipment</a></li> </ul>		
Description		
<p><b>What happened?</b> A 7.5t pickup was on site waiting to be loaded with trench boxes, as other works were going on at the time of the arrival, the pick-up was instructed to park within the CDM boundary on an 'A' road with approximately a 15% incline. The pickup was parked for 45mins within the traffic management cones, ready to be loaded.</p> <p>During the initial loading of the trench boxes there was no sign of any concern regarding the pickup. Upon completion, the slinger/signaller instructed the excavator which had been loading the pickup to move away, the green light was then given to allow the driver to secure the load.</p> <p>As the driver was securing the load, the pickup began rolling down the road, this forced the driver to jump out the way.</p> <p>The pickup

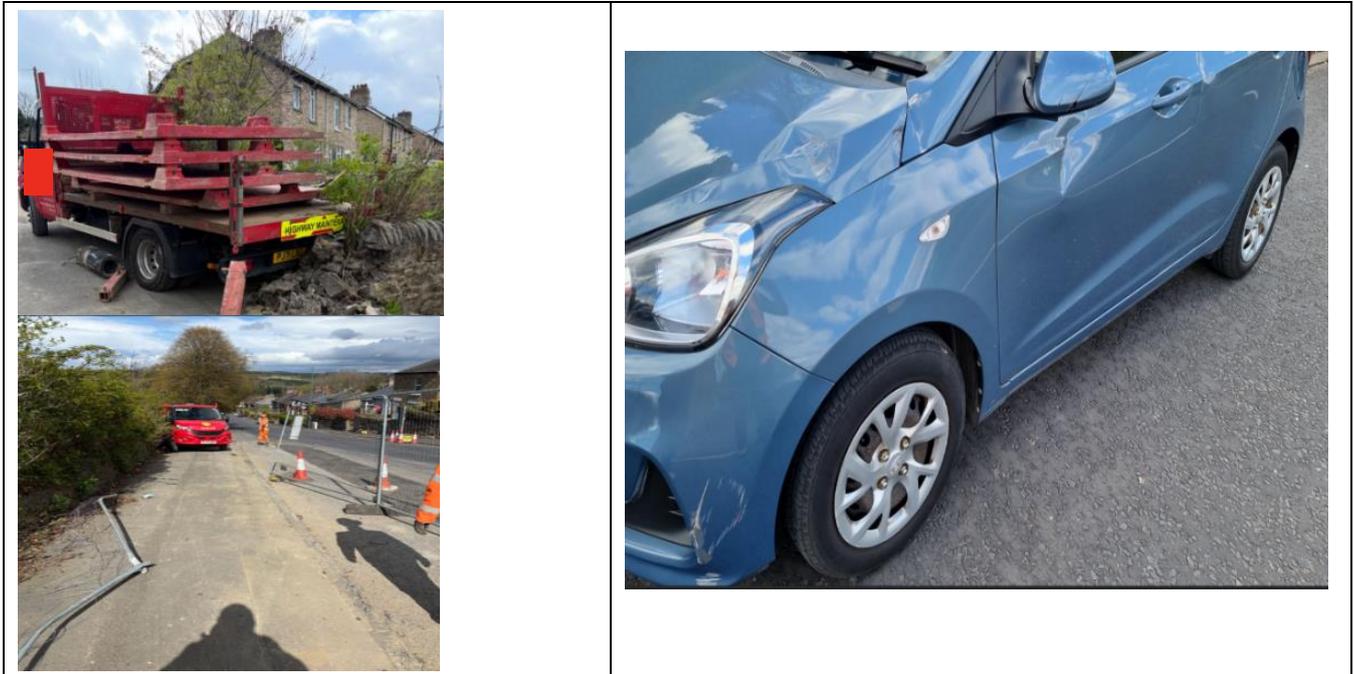
**Photo 1:** Pick-up collided with the wall

**Photo 2:** Damage to car from falling unsecured struts

- The van was removed from the footpath, parked in gear and chocked, whilst awaiting recovery.
- The footpath was cleared of any debris and re-opened.
- The resident was informed by the customer care team.
- Followed the client safety reporting directive of 2-2-2 and informed the SHEQ team.

- Continued support to the resident whilst the damage is rectified.
- Full reports of the pick-up including service, MOT history, and failure report of the vehicle.
- Where practicable avoid loading/unloading vehicles on slopes.
- Where unavoidable ensure risk controls measures are present to prevent injury/damage.
