# Safety Alert

Issue No. 1  
Date: Sept 2018

## What Happened

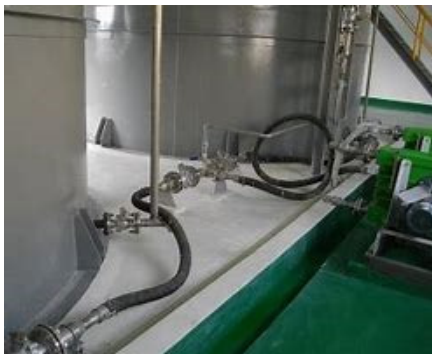
On the first occasion a caustic line ran at high level but was observed to be dripping, thus presenting a risk to anyone working beneath. Fortunately the technician secured the area and requested an immediate repair.

On the second occasion technicians lifted a cover to observe that a chamber had partially filled due to leaking caustic. Fortunately the technicians recognized the risks, secured the area and arranged for the chamber to be cleaned by specialists.

Wherever practicable, and certainly overhead, lines should be double skinned, so that a leak on the inner hose cannot harm anyone in the area.

Hoses and dosing lines should be checked, so far as possible, as a part of the routine site checks.

If you see a line that shows signs of degradation report it.

If you spot a leak, make the area safe and ensure that the hose/pipework is safely replaced at the earliest opportunity.
