Manhole Cover Incident

Operative has fallen through manhole on site

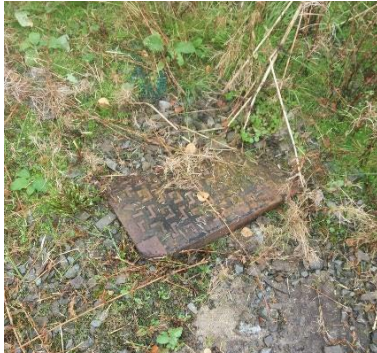
Whilst strimming, a GM Operative fell through a temporary wooden cover into a manhole chamber at Near Sawrey WwTW in Cumbria.

The manhole chamber had been covered with a wooden board which had gravel on top. The area was so overgrown with vegetation that it was not seen by the operative. Offset from the concealed manhole chamber was a partially overgrown metal manhole cover on the ground, which at the time was believed to be covering a chamber.

- Those responsible for sites check the known chamber locations and perform a visual inspection of each chamber.
- Any defects are identified and reported on AIRline.
- Any remedial actions to repair chambers and/or their covers are carried out, where required.

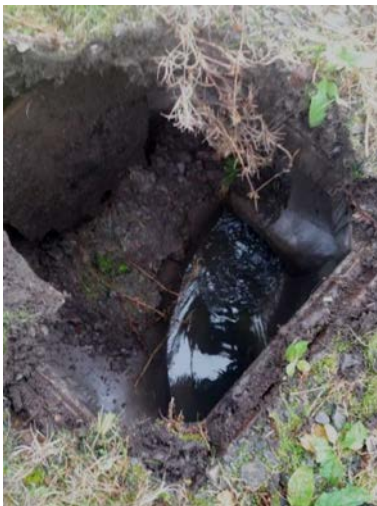
Post incident, the overgrown manhole cover was dug out of the ground, the drain top and recess were cleaned out and the manhole cover was placed over the chamber. There was no apparent reason for the cover to have been removed and to have been replaced by a temporary wooden board.
