Safety Alert (August 2022)

Mobile Compressor Injury Incident

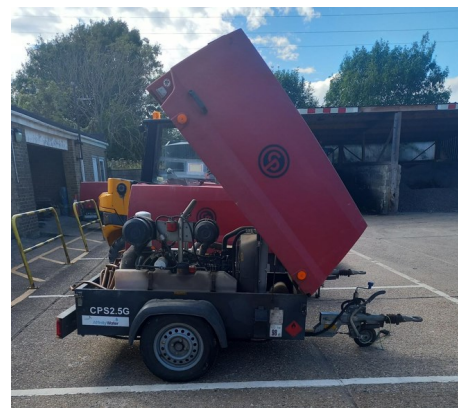
Image of mobile compressor

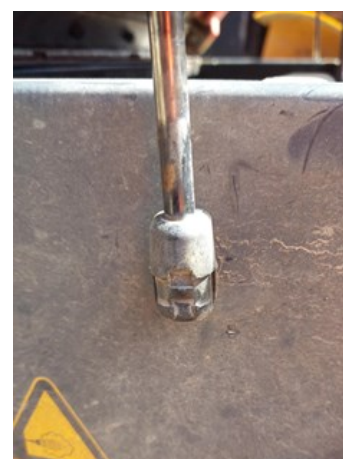
- The team were packing away at the end of a job. A member of the team lifted the canopy of the compressor to put away the air hose. As they leaned in, the canopy came down with force and fell onto their forearm, leading to a fracture of the lower arm / wrist.
- A new hinge had recently been fitted to the canopy / hood as part of planned repair work. Both rams (*mechanical stays*) were disconnected when the repair was undertaken. The compressor was brought back into service 4 days before the incident. Upon inspection post event, it was confirmed that a retaining clip was missing.

Image showing ram **without** retaining clip.

- If you are responsible for any mobile compressors, please carry out checks to ensure that the rams are fixed in place and all retaining clips in place. Any found to be defective must be immediately quarantined until appropriate repairs can be carried out.
- Consider any other plant / equipment that may have similar fixings, and also carry out the checks on these.
- Consideration should be given to the installation of mechanical stays to support the canopy in future, i.e. if a ram fails.
- Remember to always carry out thorough pre-use checks on any plant or equipment you are using, and record these checks.

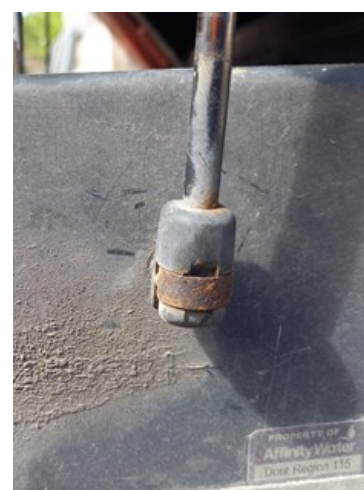
Image showing ram **with** retaining clip.
