For Anglian Water employees, partners and contractors

They are issued to raise awareness of incidents that occur and to highlight the safe work practices required to avoid them being repeated.

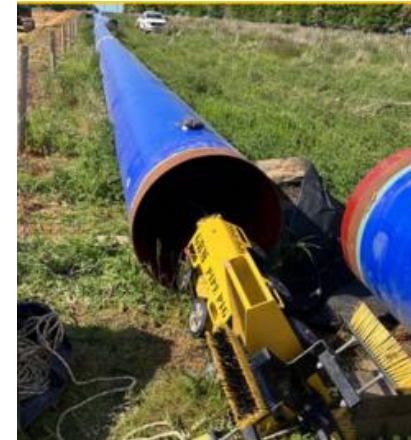
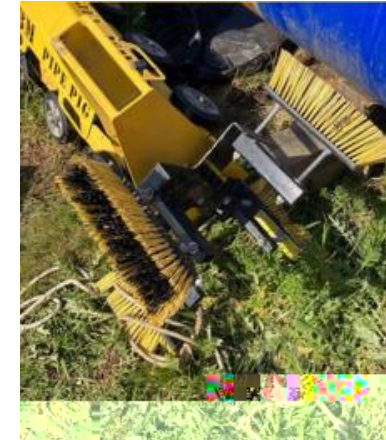
- On Monday 12 May, a team of 4 operatives were undertaking a pipe cleaning activity.
- During this process, the pipe cleaning device (Pipe 'PIG') left the confines of the pipe whilst still under power.
- At this point, the left hand of a general operative came into contact with the rotating arms of the pipe 'PIG'.
- The IP sustained a significant hand injury and was taken to hospital for surgery.
- All pipe cleaning operations using the pipe 'PIG' have temporarily ceased across SPA.
- Principal contractor and SPA SHEA advisors have been deployed to site to gather information and begin the investigation process.

- Pipe cleaning activities using the pipe 'PIG' are not to recommence until a full review of the operation has been undertaken and additional controls have been implemented to prevent contact with moving machinery that is not guarded.
- A review of RAMS and Permit documentation has been implemented.
- Please review all site activities that have the potential for contact with moving machinery to ensure suitable guarding / exclusion areas are in place.
