## Incorrect Valves used on Chlorine (CL2) Injection Lines

Incident Date: 09-02-17	NIW Safety Alert: SA12	Issue Date: 27-06-17
Datix Number	NIW2381	
Target Audience: All NI Water Field Operations Staff & Managers, Asset Delivery, & Contractors		
Prepared by:	M&E Services supported by the SHE Team	
Approved by:	Head of Safety

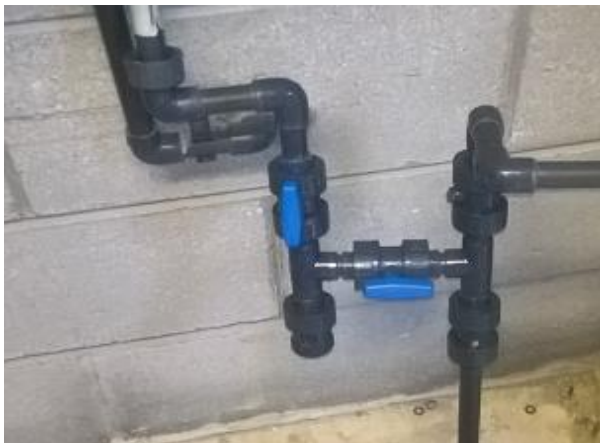
Following a report of a fault on a Chlorine Dosing System at Tullyhappy SR a work crew attended to complete a repair. The work required the crew to first isolate the Gas Injection point into the water line, as part of the safe isolation process. It was not possible to complete this task the associated valves had seized (failed to turn) and, in one case, when pressure was applied the handle sheared and broke off.

It was discovered that inappropriate valves had been fitted on the chlorine installation. These were found to be standard water valves, and not chlorine gas rated. The valves had been fitted as part of a Base Maintenance upgrade programme.

Photo 1: Water Valves - that had been fitted.

1. All valves and ancillary equipment used within any Chlorine (Cl<sub>2</sub>) Gas Installation must be of suitable design and appropriately rated.
2. Staff and contractors should be informed of this incident and made suitably aware of risks and requirements when working with such equipment or installations.
3. Only suitably trained competent staff should work on such installations.
4. Potential for incident read across should be assessed, and tested where appropriate. Recent sites that have been subject to similar upgrades and should be investigated to ensure that appropriate rated valves and ancillary equipment has been used.

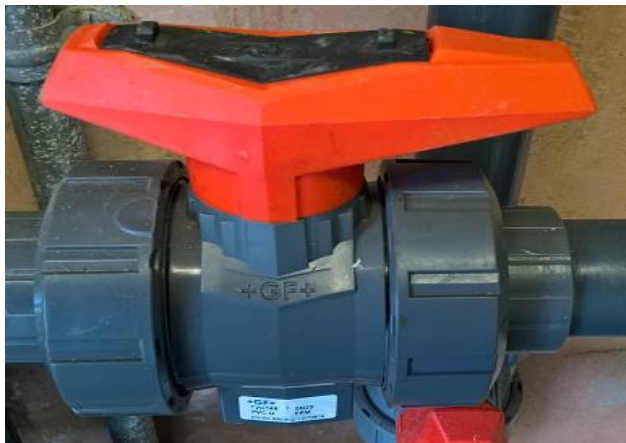
Photo 2: Gas Valve - that should have been fitted.
