M GROUP
Water

Safety Alert

Lost time Injury – Fall through a manhole

01 April 2025

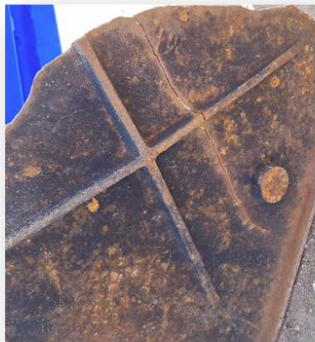
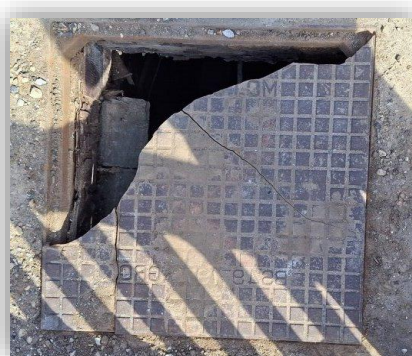
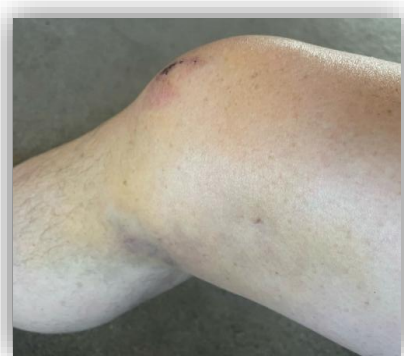
Operative arrived on site and found several plastic barriers had fallen / blown over and was in the process of reinstating them. He walked over to the lay down area to collect sandbags for the barriers. In the area, there was a concrete plinth with a manhole cover. As he stepped on the cover, he fell through into the chamber. His fall was arrested, as the chamber contained redundant apparatus.

The operative suffered an injury to their knee and was assisted out of the chamber, where first aid was administered. He was later taken to A&E as his right knee became swollen.

If you observe, damaged or defective covers within our work areas these must be protected and secured against people walking across them. Always raise any observations via the QR codes or to the site managers & your supervisor if the hazards cannot be resolved.

Where possible install additional temporary barriers or secure covers to cover the manhole. These can be as simple as a few traffic cones, site barriers, footway boards etc or temporary warning signs. Place appropriate signs / barriers to warn others of the hazards.

Broken or damaged covers must be raised with the site you are working on or asset owners who will hopefully come and quickly repair.
