Safety Bulletin

Safety in Chambers

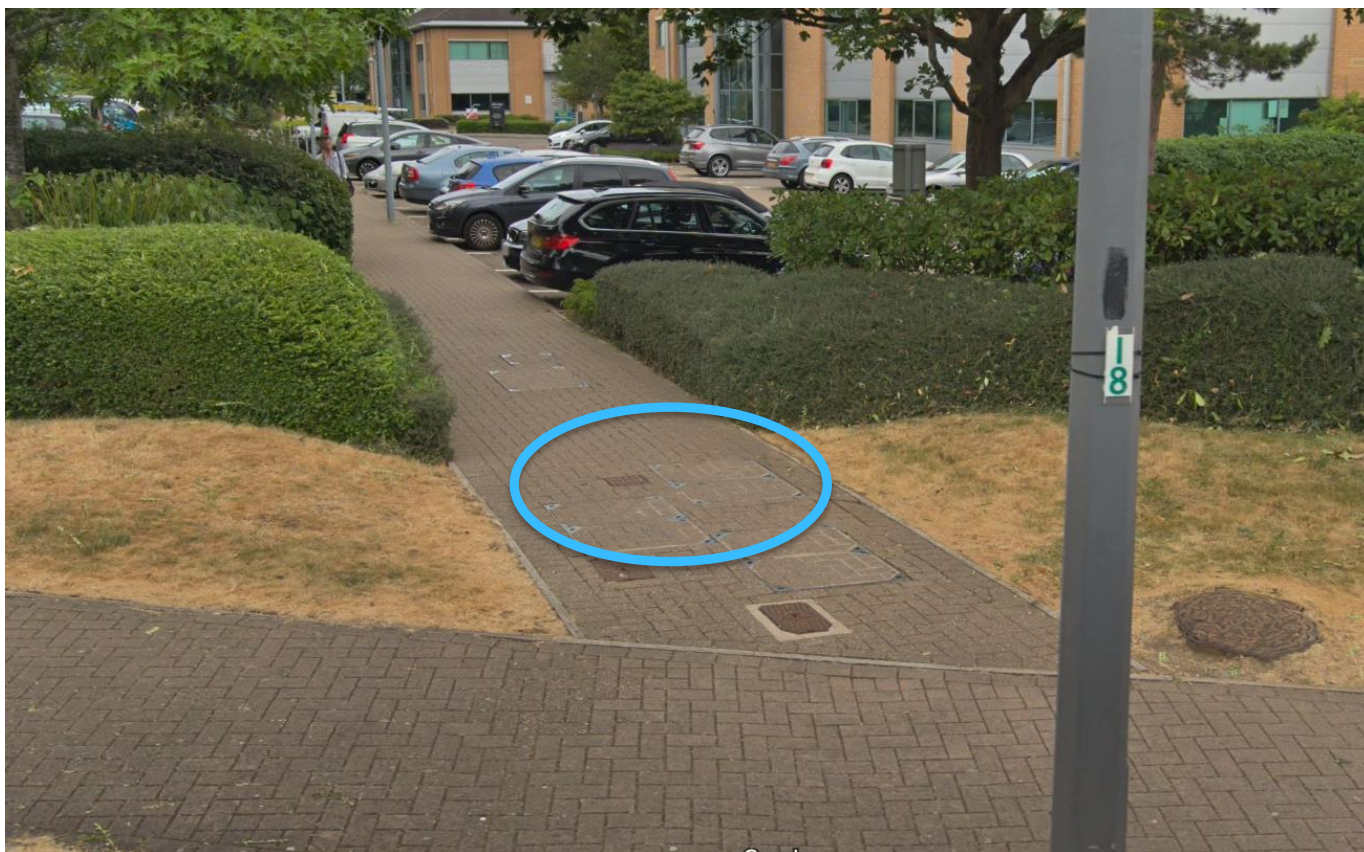
An employee had been tasked with checking a meter due to a suspected fault. The chamber was located in a footpath in the Aztec West business park and contained a water supply used for watering the gardens. The footpath had several covers and lamp posts suggesting that numerous other types of services were in the same footpath.

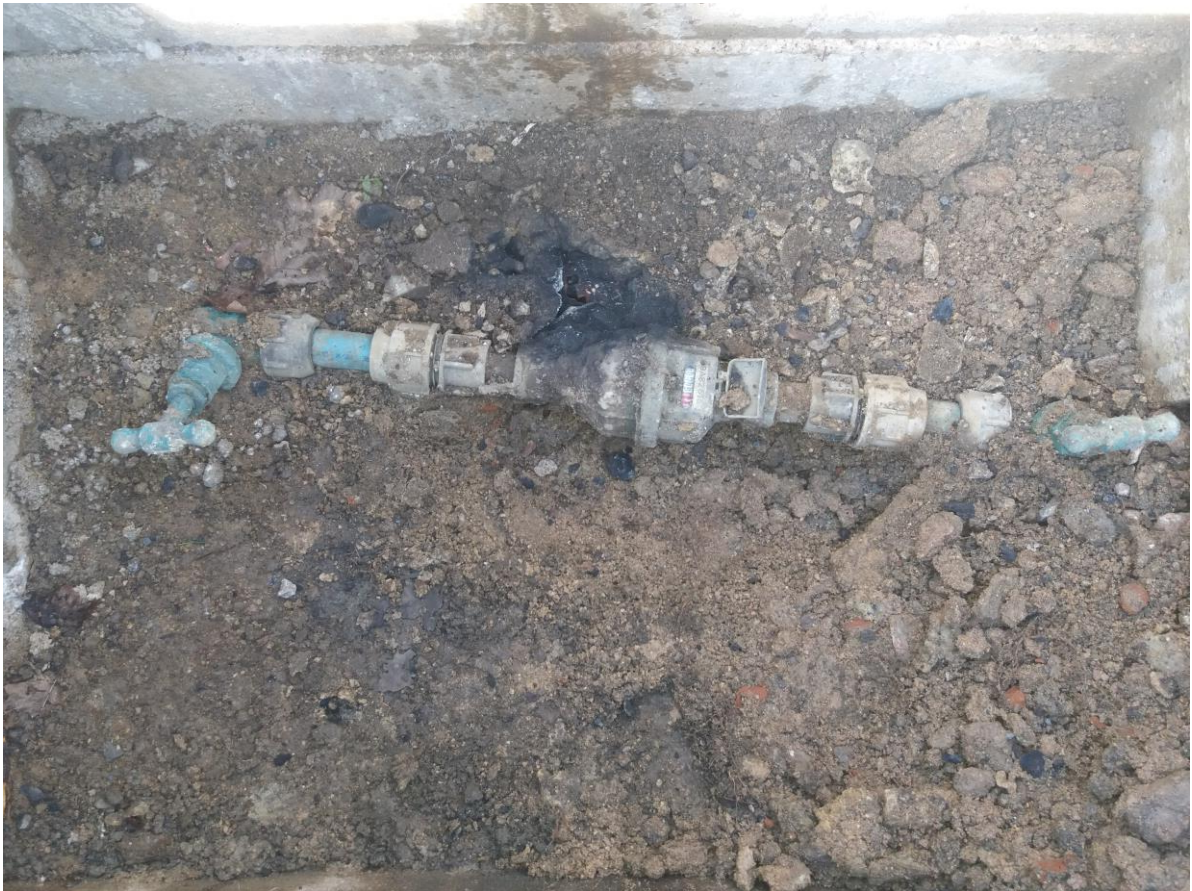
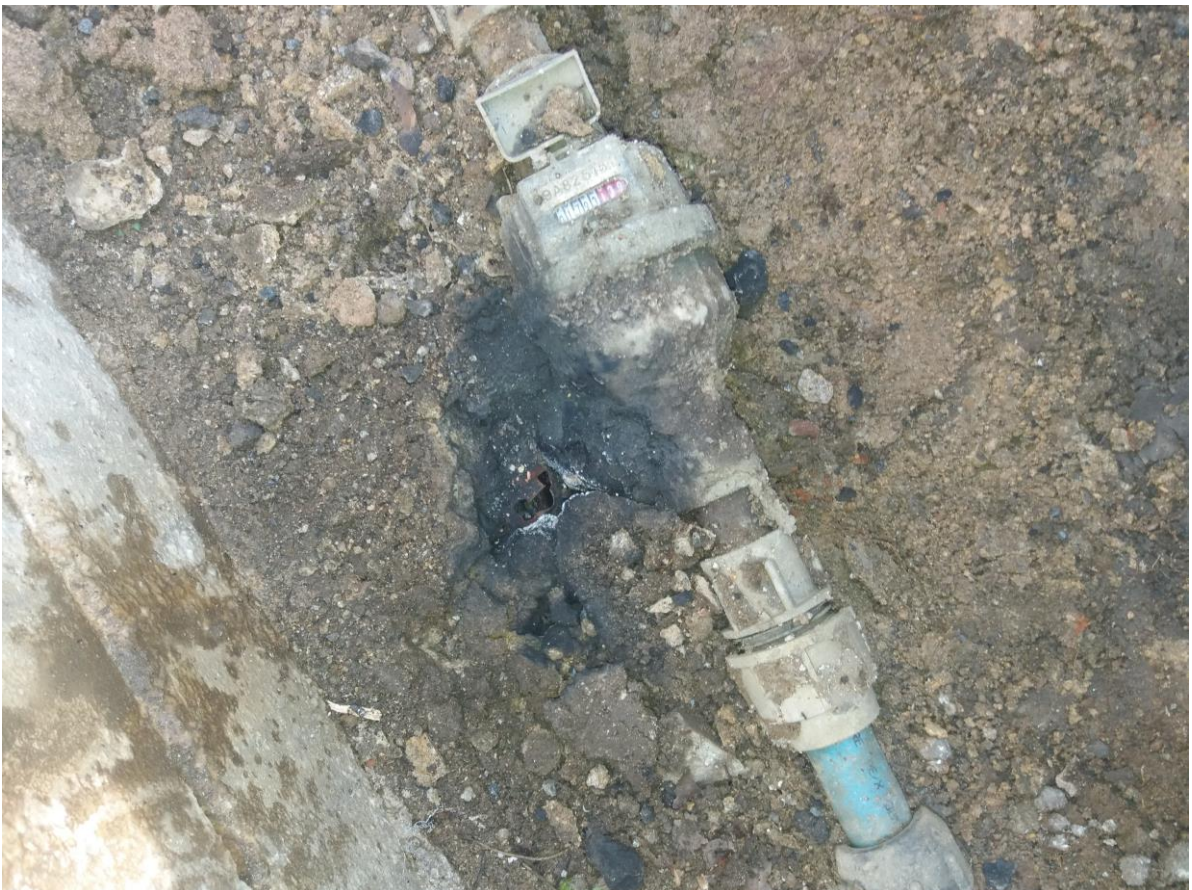
Due to the age of the meter (circa 20 years) the two-person crew decided to replace the meter as it was due for replacement and this may have fixed the suspected fault. Working as a team, they lifted the chamber cover to reveal a blue poly pipe and meter partially encased in spoil. The spoil was type 1 aggregate and had hardened over time and could not be removed with a scoop. One of the team obtained their insulated grafting tool to loosen the aggregate whilst the other team member completed the details of the job in the work management system. As the employee gently loosened the material, a bang and a flashover occurred causing a partial thickness burn (second degree burn) to his forearm, slight burns to his face and hair as well as burning the high visibility jerkin that he was wearing and scorching his trousers. Our colleague had struck an 11,000 volt electrical cable that was just below the surface of the aggregate and was below the water supply pipe. He was taken to Southmead hospital and treated for burns.

The accident is still under investigation to identify the root cause however we need to make the assumption that all our water meter chambers have the potential to contain other underground services particularly power cables as these have the potential to cause the most harm. As a minimum, you must carry out a dynamic risk assessment. Your risk assessment will help to determine what risks are present. Meter chambers should be scanned using a Cable Avoidance Tool (CAT) **and** signal generator prior to any work being carried out. You should also check the surrounding area for external street furniture to give you a guide that underground services may be present. If underground services are detected, your line manager must be contacted and a request made for a full utility pack which includes drawings to enable you to locate any services. No breaking of ground or scooping with metal scoops should take place until you have established all the risks and you have obtained permission from your line manager.

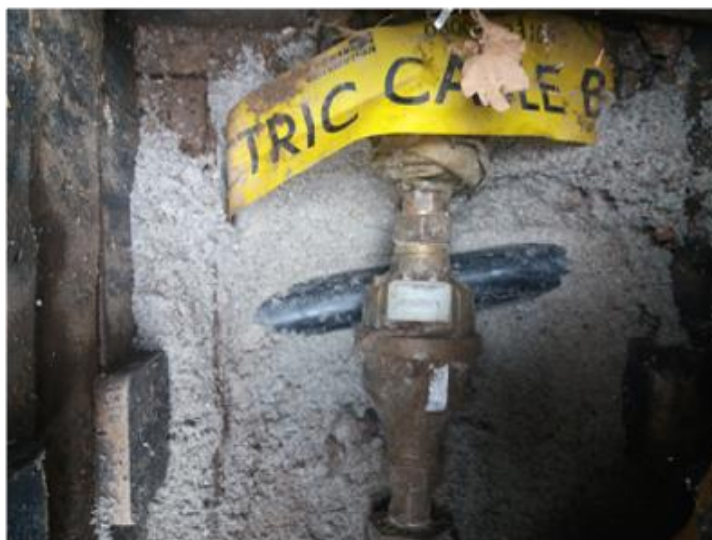
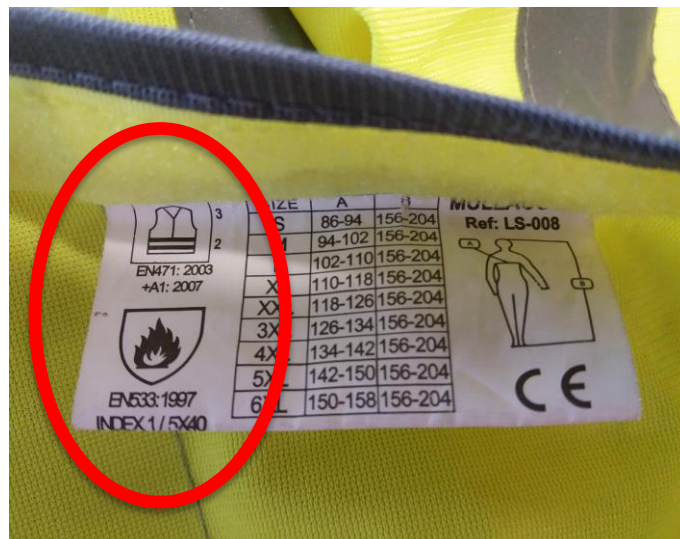
It was thought that this may have been a one-off incident however following this accident, a hazard has been reported where another meter chamber has been found to contain a power supply cable directly beneath a water supply pipe. Discussions with other water companies has highlighted that the potential for other services to be located in water meter chambers is not as uncommon as you would think and may be on the increase due to the installation of meter chambers by third parties.
