# Safety Alert

## ***SA184 Foot injury from Cut off Saw***

***December 2025***

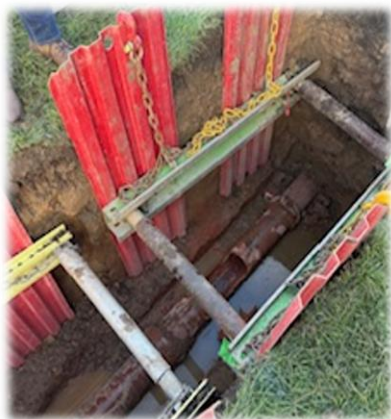
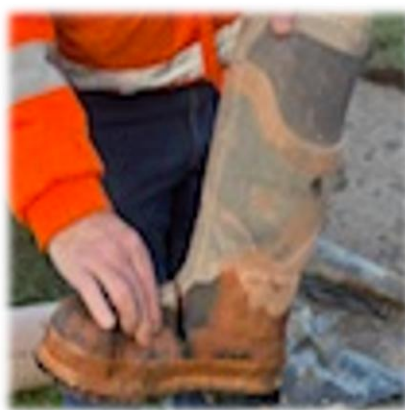
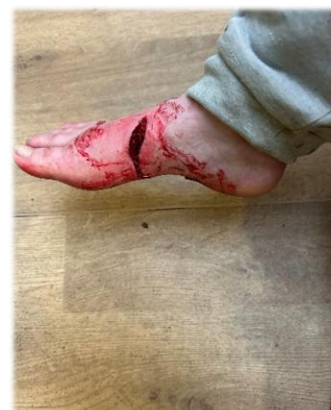
### **Photos of the site and IP's injuries**

On 8th December 2025 a serious accident occurred at an Esh Construction site on the NWG Runway 1 Repairs & Maintenance Framework . An Esh employee received major foot injuries when the cut off saw the IP was using recoiled whilst cutting a 6-inch clay pipe while working on within the trench.

The impact of the recoil caused the saw to contact the IP and cut through the IP's safety footwear. The IP was administered first aid at site and then taken to hospital, the IP's injuries were assessed where it was concluded that the IP injuries consisted of, tendon, nerve & bone damage as well as a nick to main arteries in the foot. The IP subsequently had surgery to their foot and has been realised from hospital to start their rehabilitation.

Initial review established that the works were been carried out correctly , however the IP unfortunately had their feet straddled over the pipe within the cutting zone due to restrictions with the trench bracing

- Ensure that you are positioned correctly before cutting .
- All operators of cut off saws must hold abrasive wheels training.
- Consider the available space within open excavations and remind crews to review how difficult obstructions, such as shallower mains utilities, may impact the ability to complete a relatively common task safely
- If any extra safety precautions are available for equipment, ensure they are utilised
- Review risk assessments to ensure that all activities have been fully assessed.
- Any learning will be shared once the investigation has been carried out
