Conquip Boat Skip (CA122-03000) Recall

Safety Alert

Conquip Boat Skip (CA122-03000)

Date: 16/01/2019

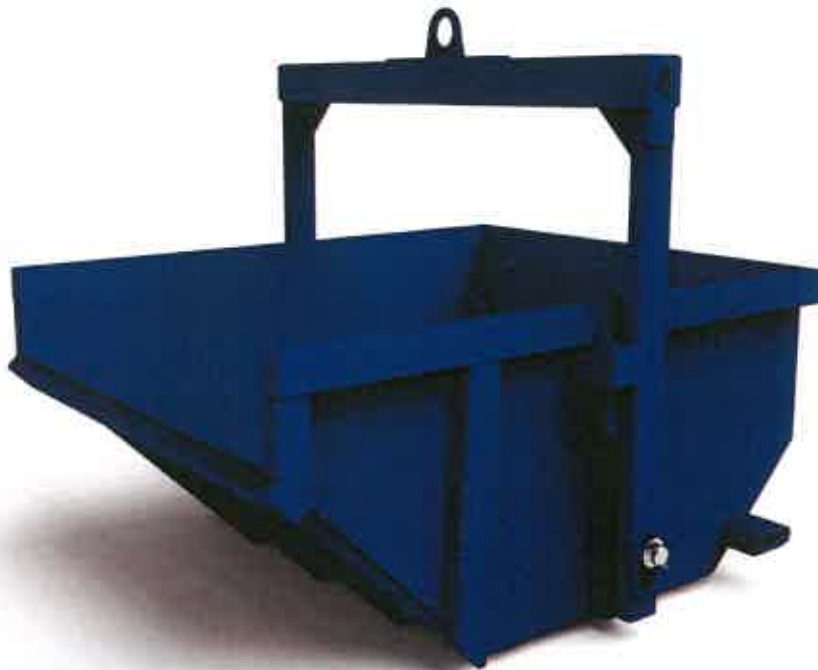
Conquip Engineering Group are issuing a Safety Alert for the CA122-03000 Boat Skip. An issue with 2015 models has been identified which could potentially cause the weld around the captive washer on the end of the pivot pin to fail.

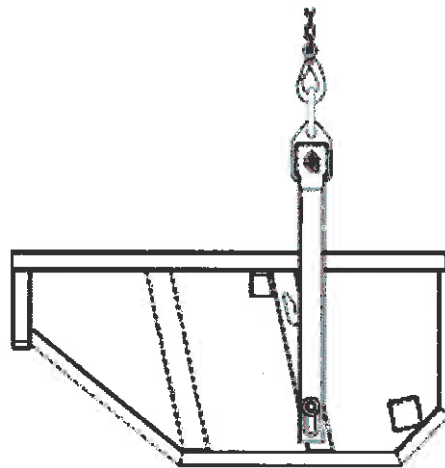
Check the items below and tick the boxes accordingly.	Yes	No
Are all nuts and fixings tight?		
Is the pivot pin (Item 2, FIG 1) able to rotate through the bale arm and skip body, and are the welds on the captive washer (Item 4, FIG 1) sound?		
Does the bale arm function correctly?		
Is the skip body sound and free from structural damage?		
Does the lifting eye show signs of elongation or damage?		
Are the welds around the lifting eye and bale arm free from defects?		
Is the master-link damage free and serviceable?		
Is the Working Load Limit clearly displayed?		
Is a test lift completed?
