Safety Bulletin

Target Audience	All Drivers Company / Personal	Ref No.	BG0026
Authorised by	Barry Gaffney	Date Issued	09/05/2022

Topic Description

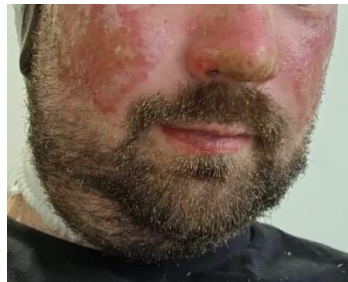
The person parked their personal car in front of the office and whilst still in their personal car ignited a cigarette which caused the vapour from the **Holts TYREWELD** emergency puncture repair kit to ignite causing a vapour fire inside the vehicle.

Upon investigation by the London Fire Brigade, it was discovered that the **Holts TYREWELD** emergency puncture repair kit stored under the vehicle's front seat was leaking. The vapour from the leak built up within the vehicle and when the cigarette was ignited a vapour fire occurred.

The images show the extent of the injury after the vapour fire occurred and the burns to their arm and face.

- No smoking is permitted in any company vehicles / machines. If you must smoke, please use dedicated smoking areas only.
- Never use aerosols in confined spaces unless fully ventilated
- Avoid carrying aerosols and flammable substances in your vehicle.
- Never store any emergency puncture repair kits under the seats of vehicles, always store them in the boot of the vehicle.
- Carry out regular checks for leakages on emergency puncture repair kits especially the **Holts TYREWELD** type that is shown in this bulletin.
- Protect aerosols from sunlight. Do not expose to temperatures exceeding 50 Celsius.
- Ensure your vehicle / machine is kept clean and free of rubbish such as paper, food wrappers, boxes and other items that can impede the safe driving of the vehicle / machine.
- *If in doubt seek assistance*
